## YOUR INSPECTION REPORT

Sample report  
Fort Collins, CO 80525

Saturday, June 13, 2015

RE: Report No. 1005  
Sample report  
Fort Collins, CO  
80525

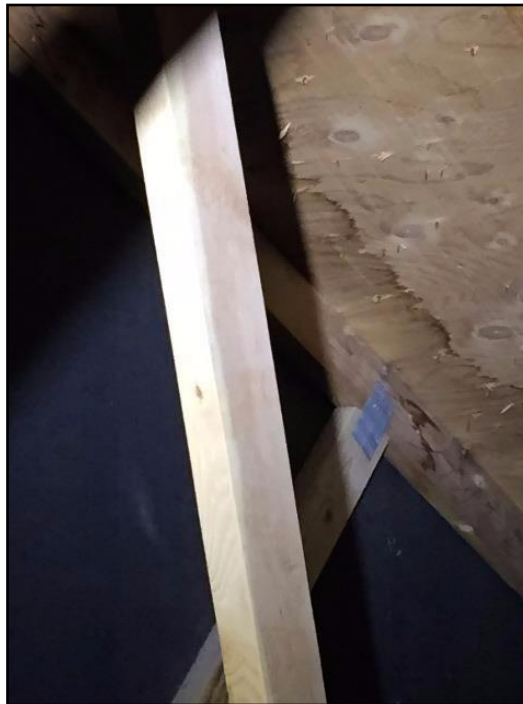
5. Leak

#### 1. Condition: • [Leak](#)

Roof Decking (sheathing) at junction point where the roof above the garage meets the second story exterior wall showed evidence of significant moisture damage. Discoloration of sheathing and evidence of leaking was present at time of inspection. Lack of flashing is the probable cause of this condition. Recommend repair of roof sheathing and the installation of a proper flashing as soon as possible by a licensed, qualified ROOFING CONTRACTOR. Failure to do so will lead to major damage and costly repairs.

**Implication(s):** Chance of water damage to contents, finishes and/or structure

**Task:** Repair

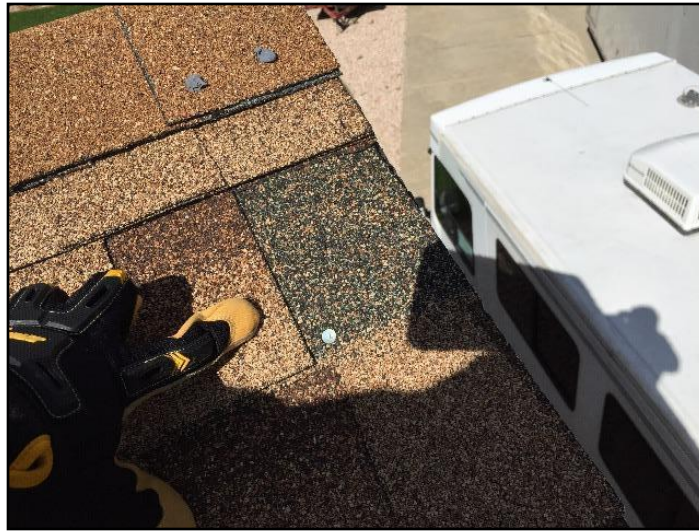
6. Missing, loose or torn

#### 2. Condition: • [Missing, loose or torn](#)

**Implication(s):** Chance of water damage to contents, finishes and/or structure

**Task:** Replace

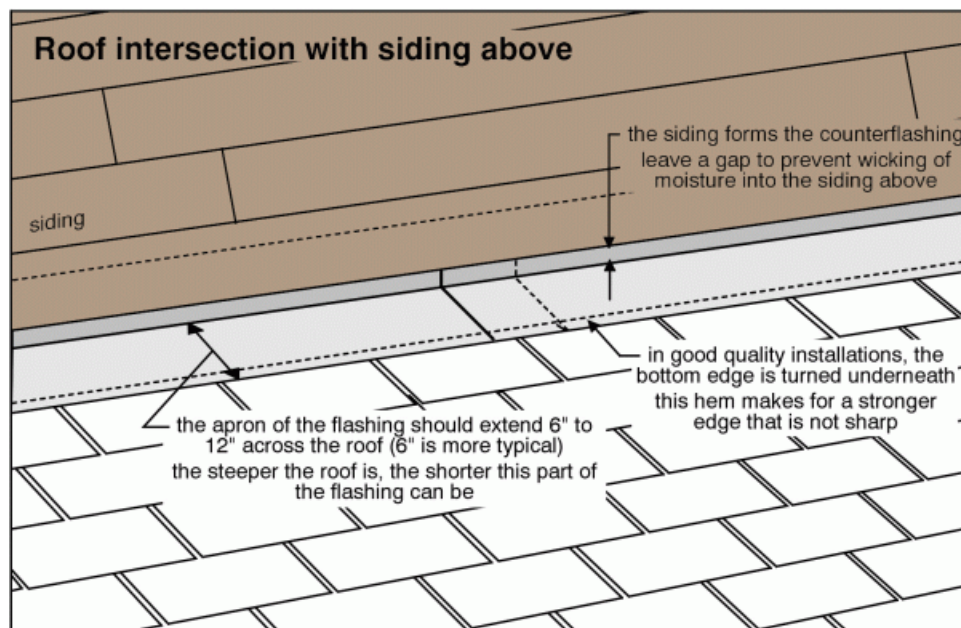
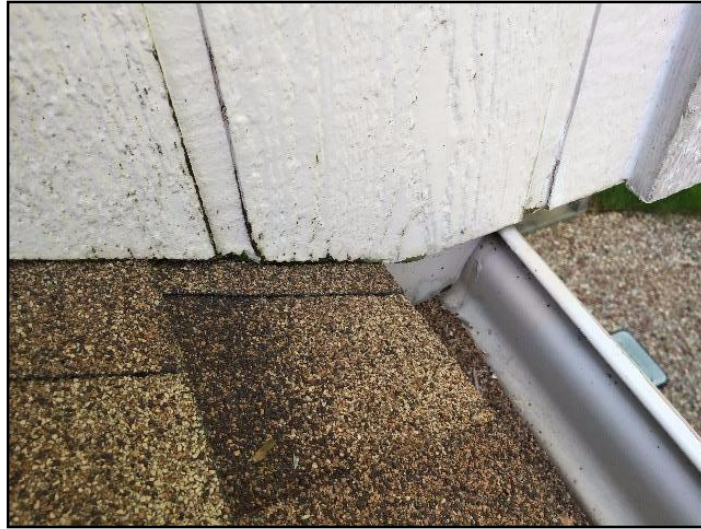
*7. Siding not cut back*

### 3. Condition: • [Siding not cut back](#)

Signs of rotting on siding above roof covering. Recommend further evaluation by a professional roofing contractor.

**Implication(s):** Chance of water damage to contents, finishes and/or structure

**Task:** Further evaluation

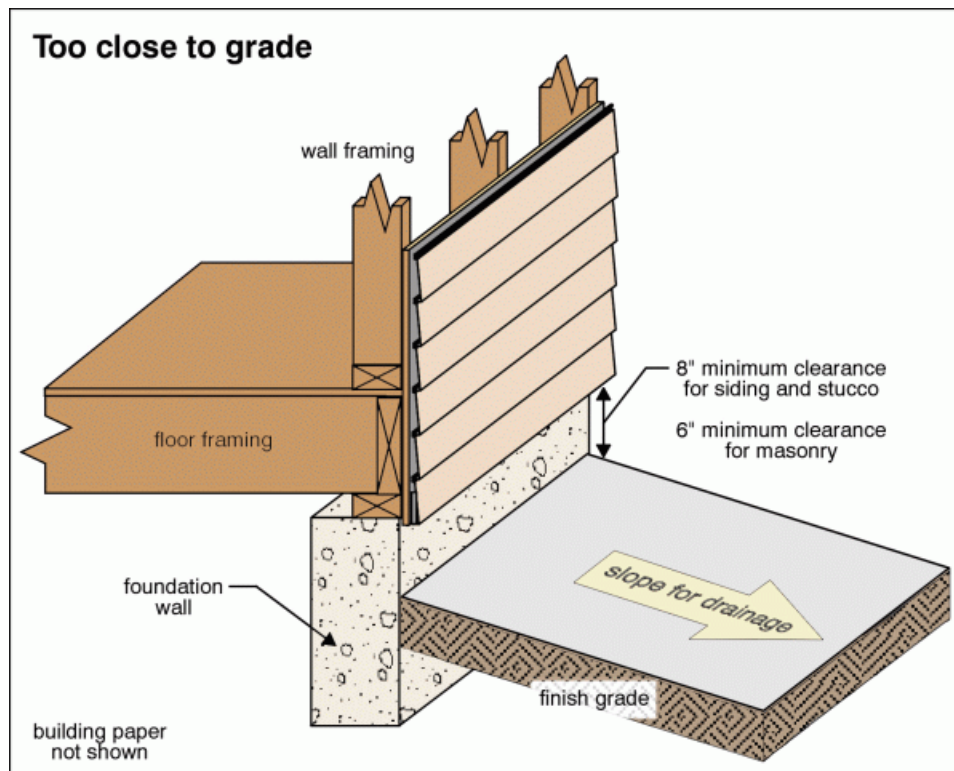
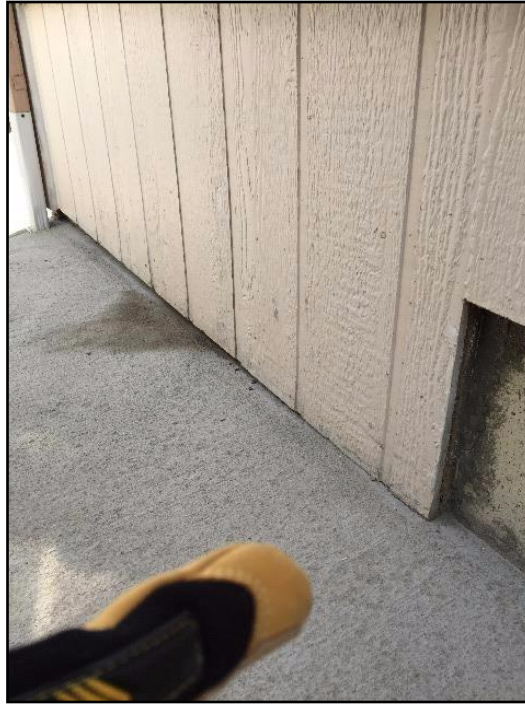
13. Too close to grade

#### 4. Condition: • [Too close to grade](#)

Siding on north side of home is in direct contact with newer portion of driveway. Recommend a qualified contractor make repairs and replacements to prevent further damage to siding.

**Implication(s):** Chance of water damage to contents, finishes and/or structure | Material deterioration | Rot | Insect damage

**Task:** Repair

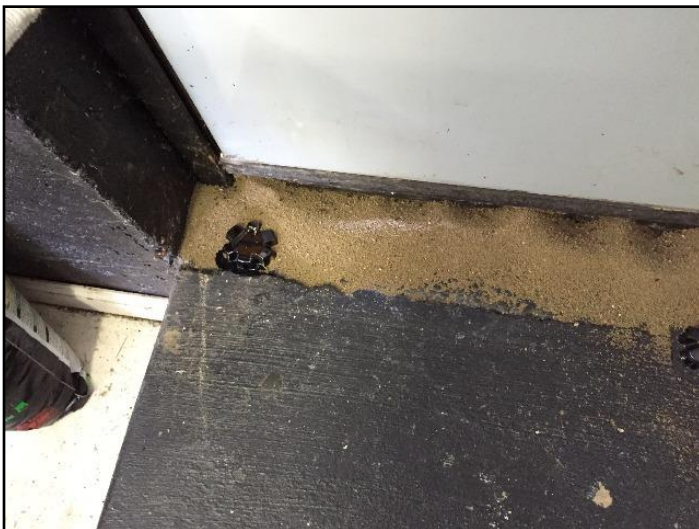
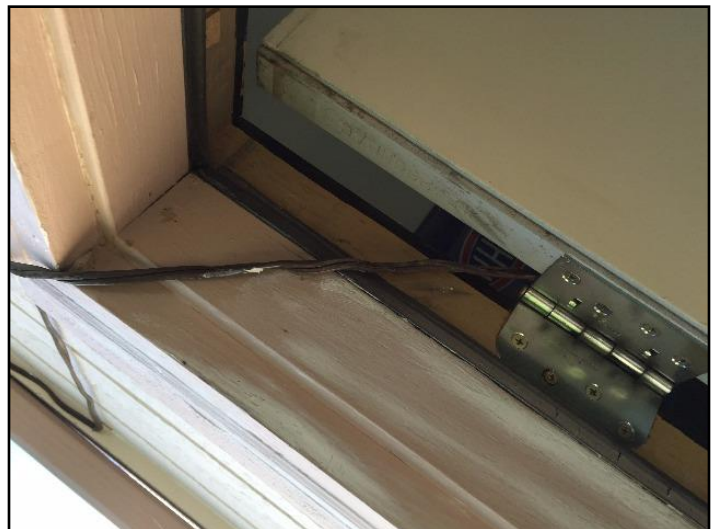
**5. Condition:** • Weather stripping on exterior door leading into garage is deteriorating and cable found improperly leading through door. Also, ants have entered the garage at the base of the door. Recommend a qualified contractor replace the weather stripping or entire door.

**Task:** Replace

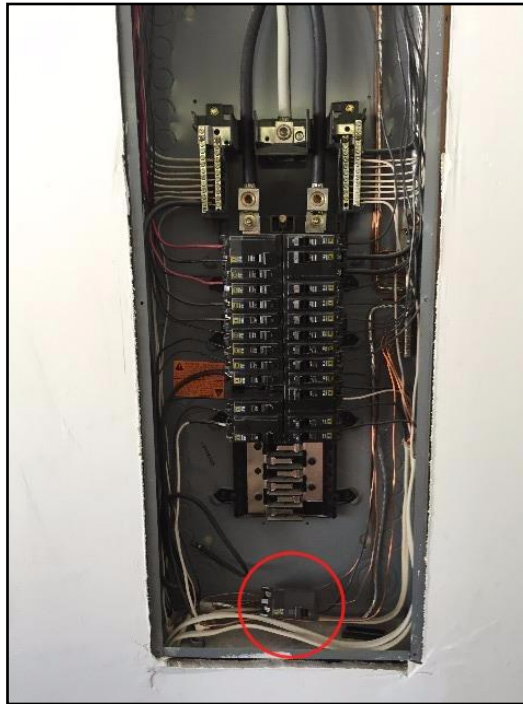
19. Loose breakers or fuses

#### 6. Condition: • [Loose breakers or fuses](#)

Extra breaker found resting at bottom of panel. Recommend further evaluation by a licensed and qualified electrician.

**Implication(s):** Electric shock | Fire hazard

**Task:** Further evaluation

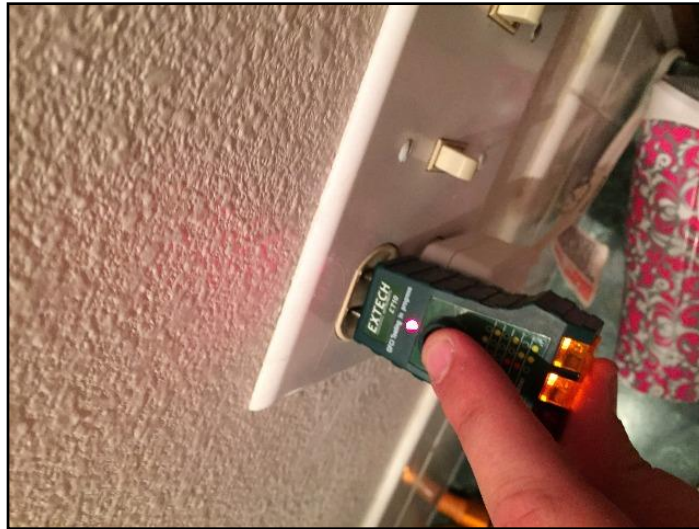
20. No GFI (Ground Fault Interrupter)

### **7. Condition:** • [No GFCI \(Ground Fault Circuit Interrupter\)](#)

Current standards call for GFCI protected outlets in bathrooms. Outlet near sink in basement bathroom was not GFCI protected. Recommend replacement by a licensed electrician.

**Implication(s):** Electric shock

**Task:** Replace

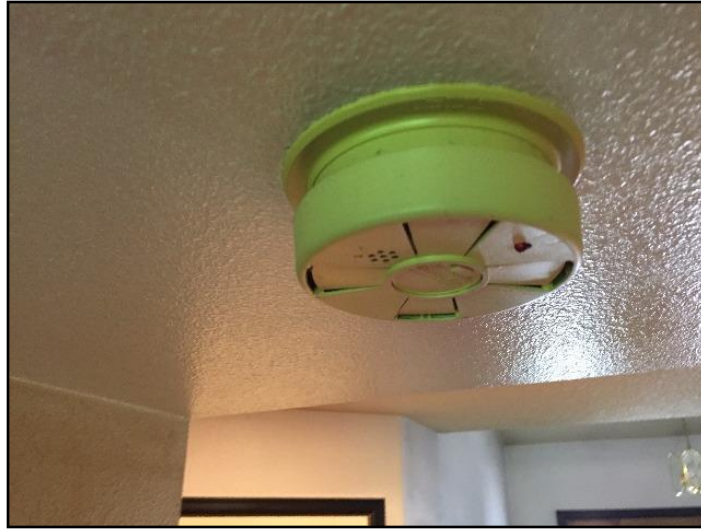
21.

8. Condition: • Smoke detector near end of life expectancy.

Implication(s): When smoke detector plastic turns yellow it is a sign that they are at the end of life and should be replaced.

Task: Replace

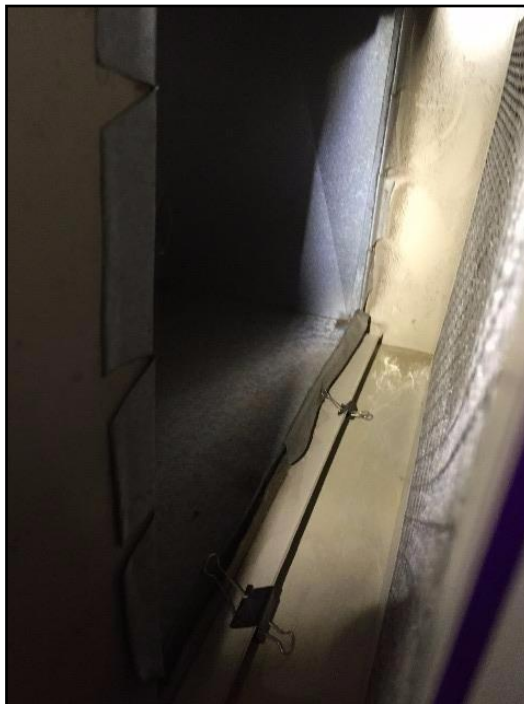
**23.** *Loose or collapsed*

**10. Condition:** • [Loose or collapsed](#)

Air filter not installed correctly. Recommend correctly installing filter in channel provided up against the return air supply. Monitor monthly and replace when dirty

**Implication(s):** Increased fire hazard | Increased heating costs | Reduced comfort

**Task:** Improve

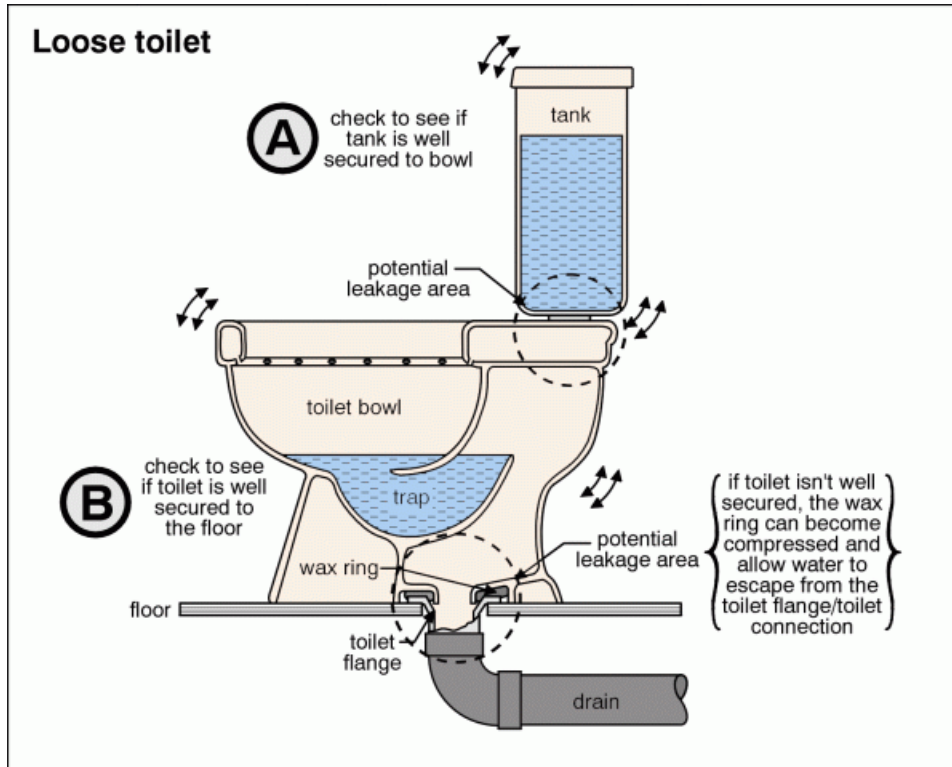
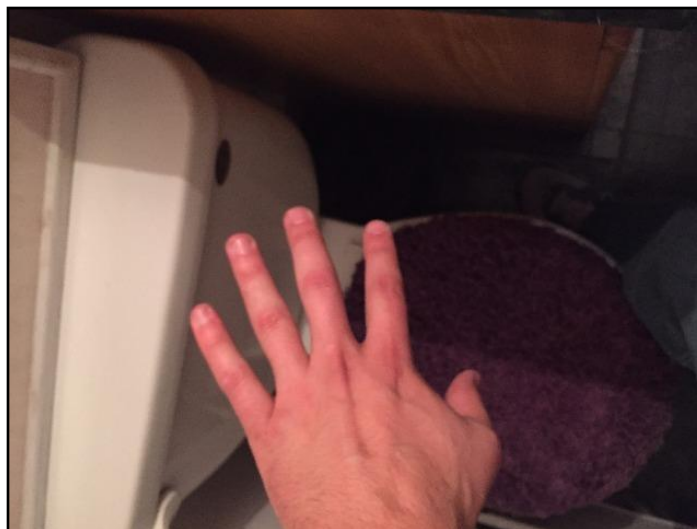
28. Loose

12. Condition: • [Loose](#)

**Implication(s):** Chance of water damage to contents, finishes and/or structure | Sewage entering the building

**Task:** Repair or replace

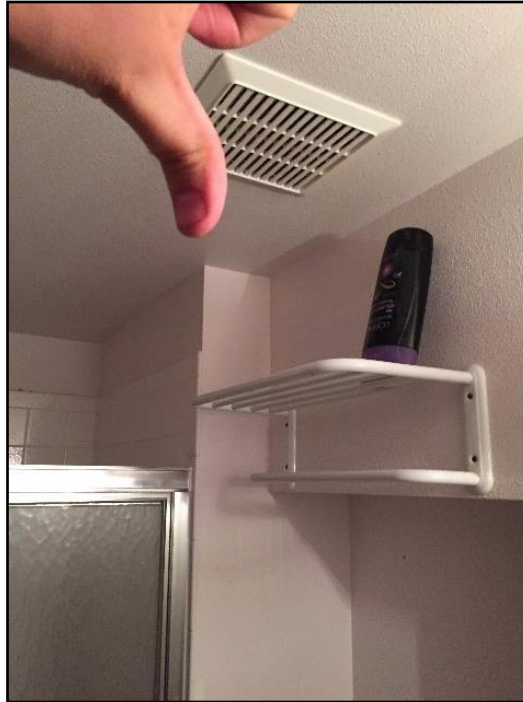
31. Inoperative

#### 13. Condition: • [Inoperative](#)

Ventilation fan in basement bathroom was inoperative at the time of inspection. Recommend repair or replacement by a qualified professional.

**Implication(s):** Chance of condensation damage to finishes and/or structure

**Task:** Repair or replace

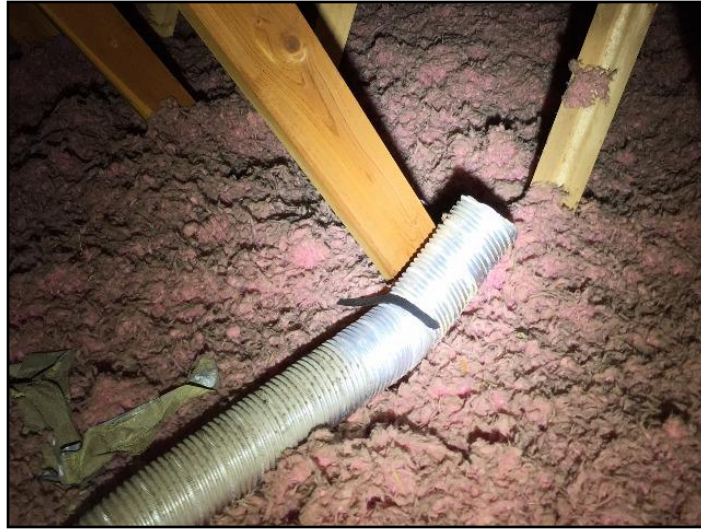
32. *Not well secured*

**14. Condition:** • Not well secured

The bathroom fan was observed to exhaust into the attic, which is an improper INSTALLATION. The fan should be vented to the exterior, either through the roof or through an outside wall, rather than to the soffit vent at the eaves of the roof. The present installation permits the bathroom fan to vent moisture into the attic space, which can reduce the R-value of the insulation, and promote mildew and mold growth on the underside of the roof sheathing. Recommend correction of the bathroom fan vent so that it exhausts to the exterior.

**Implication(s):** Damage to equipment

**Task:** Repair
